Supplemental Service Manual

906-2150-002 Rev. C, TEXT ONLY

***Centurion** Vision System Supplemental Service Manual**

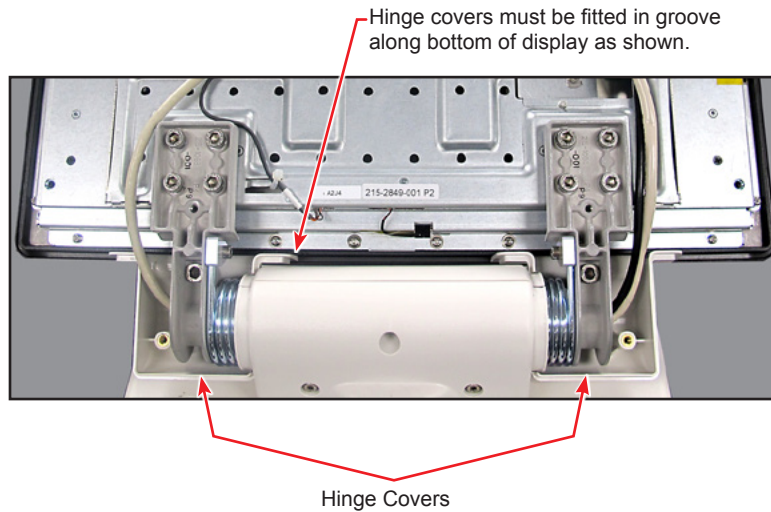
- Install eight 5 mm screws but do not tighten until hinge covers are in position as shown in [Figure 3-44](#).
- Alternately tighten eight 5 mm screws securing Display to hinge.

Figure 3-44 Display Hinge Cover Placement

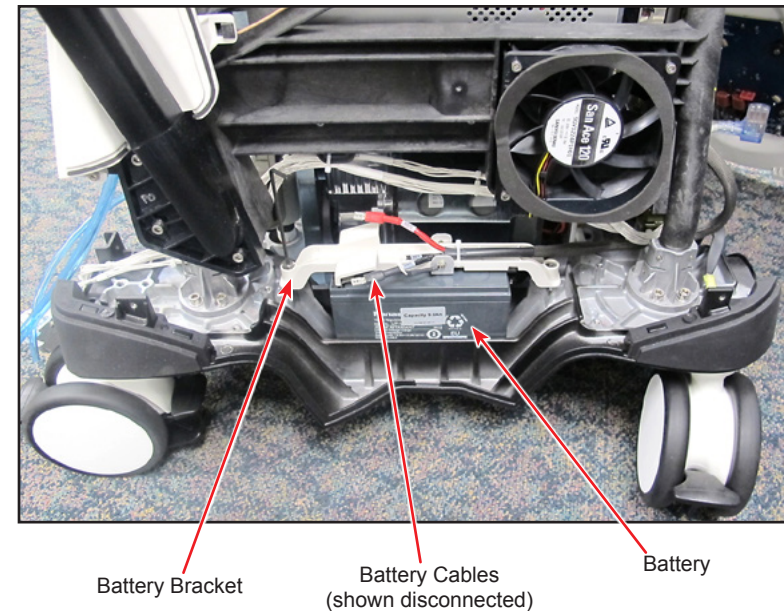
- 38.1 Remove Upper and Lower Rear Panels.
- 38.2 Remove Front Vent, Upper and Lower Front Panels.
- 38.3 Remove Upper and Lower Left Panels.
- 38.4 Remove Upper and Lower Right Panels.
- 38.5 Remove orange 40 A fuse from MFIO PCB.
- 38.6 Disconnect cables from battery (see [Figure 3-45](#)).

Figure 3-45 Battery Removal

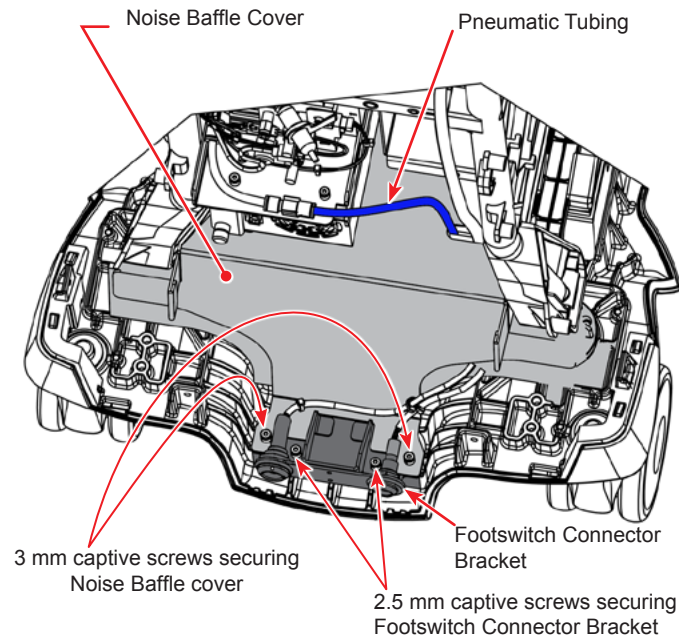
- 39.1 Remove Upper and Lower Rear Panels.
- 39.2 Remove Front Vent, Upper and Lower Front Panels.
- 39.3 Remove Upper and Lower Left Panels.
- 39.4 Remove Upper and Lower Right Panels.
- 39.5 Remove Front Bumper.
- 39.6 Remove Front Foot Handle Panel.
- 39.7 Disconnect blue pneumatic tubing from Pneumatic Manifold (see [Figure 3-46](#)).

Figure 3-46 Noise Baffle Cover Removal

- 39.8 Loosen two 2.5 mm captive screws securing footswitch connector bracket to chassis.
- 39.9 Loosen two 3 mm captive screws securing Noise Baffle cover to chassis.

- 45.6 Loosen two 3 mm captive screws securing Noise Baffle cover to footswitch connector bracket (see [Figure 3-46](#)).
- 45.7 Carefully pull Noise Baffle cover from chassis while adjusting tubing and footswitch connector bracket for clearance. Take care not to damage foam insulation attached to the underside of the Noise Baffle cover.

- 65.1 Remove Front Foot Handle Panel per step [7](#).
- 65.2 Disconnect blue pneumatic tubing from Pneumatic Manifold (see [Figure 3-46](#)).
- 65.3 Loosen two 2.5 mm captive screws securing footswitch connector bracket to chassis (see [Figure 3-46](#)).

- 65.4 Loosen two 3 mm captive screws securing Noise Baffle cover to chassis (see [Figure 3-46](#)).
- 65.5 Carefully pull Noise Baffle cover from chassis while adjusting tubing and footswitch connector bracket for clearance. Take care not to damage foam insulation attached to underside of the Noise Baffle cover.

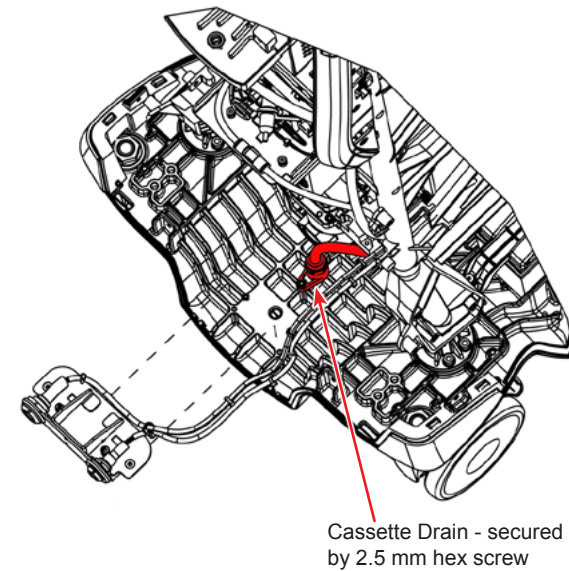
- 39.10 Carefully pull Noise Baffle cover from chassis while adjusting tubing and footswitch connector bracket for clearance. Take care not to damage foam insulation attached to the underside of the Noise Baffle cover.
- 39.11 Remove one 2.5 mm hex screw securing Cassette Drain to chassis (see [Figure 3-47](#)). Reposition Cassette Drain to provide clearance for pump removal.

Figure 3-47 Cassette Drain Removal

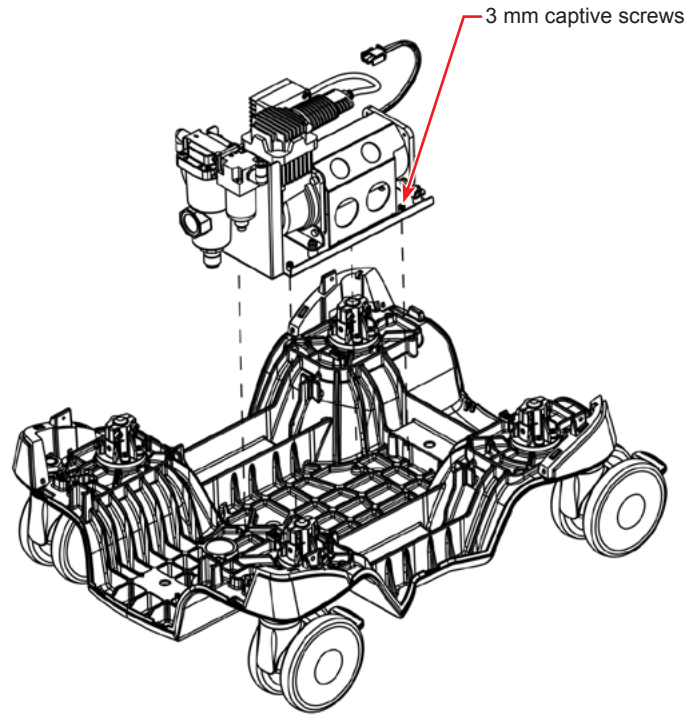
- 39.12 Remove both batteries per step [38](#).
- 39.13 Disconnect Pump Power connection at J4 on MFIO PCB.
- 39.14 Loosen four 3 mm captive screws securing pump to chassis (see [Figure 3-48](#)).
- 39.15 Reposition pump as necessary and remove from front of console.

Figure 3-48 **Pneumatic Pump Removal**

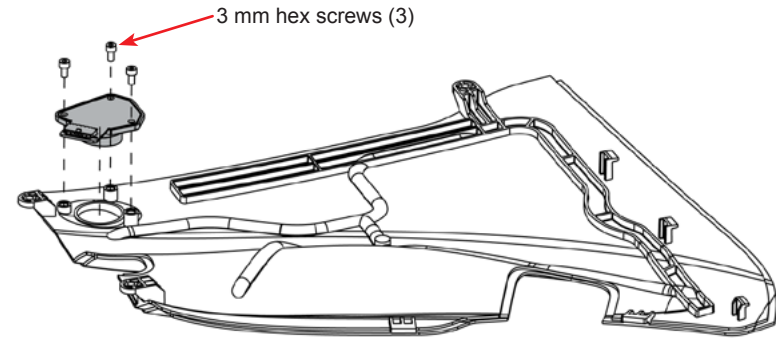
- 40.1 Remove Upper Left Panel.
- 40.2 Disconnect J1 from Standby Switch PCB.
- 40.3 Remove three 3 mm hex screws securing PCB to panel (see [Figure 3-49](#)).

Figure 3-49 **Standby Switch Removal**

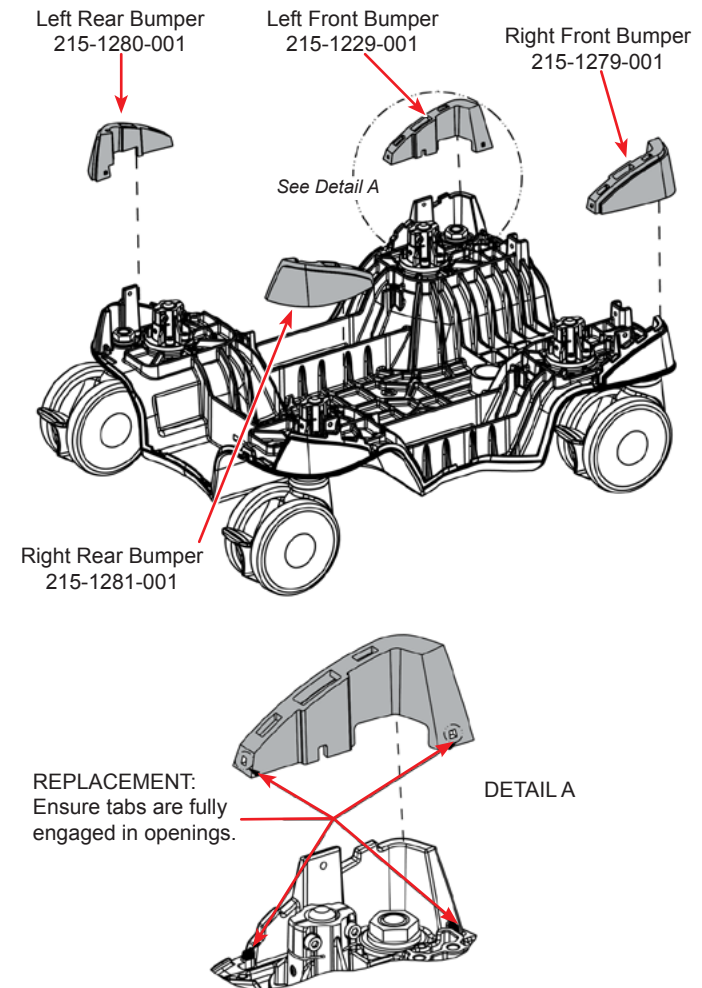
- 41.1 Remove panels listed in table below to gain access to bumper to be replaced. Refer to [Figure 3-50](#) for Bumper location.

- 41.2 Pull bumper off tab at each side and remove from chassis.

Figure 3-50 Rubber Bumper Removal

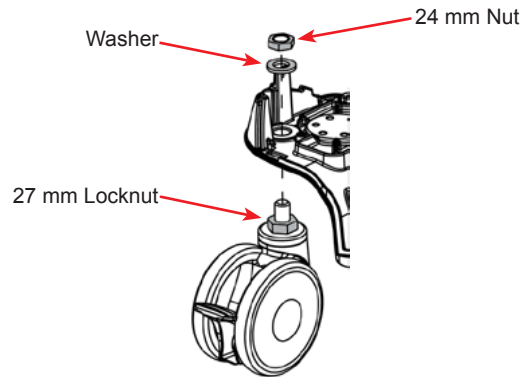
- 42.1 Remove panels as necessary per [Table 3-3](#) to gain access.
- 42.2 Lock casters opposite the caster to be removed.
- 42.3 Lift side with caster to be removed. and place a solid object under the chassis so that there is enough clearance above floor to remove the caster.
- 42.4 While holding the 27 mm locknut in place, remove the 24 mm nut and washer using a deep 24 mm socket wrench (see [Figure 3-51](#)).

Figure 3-51 Caster Removal

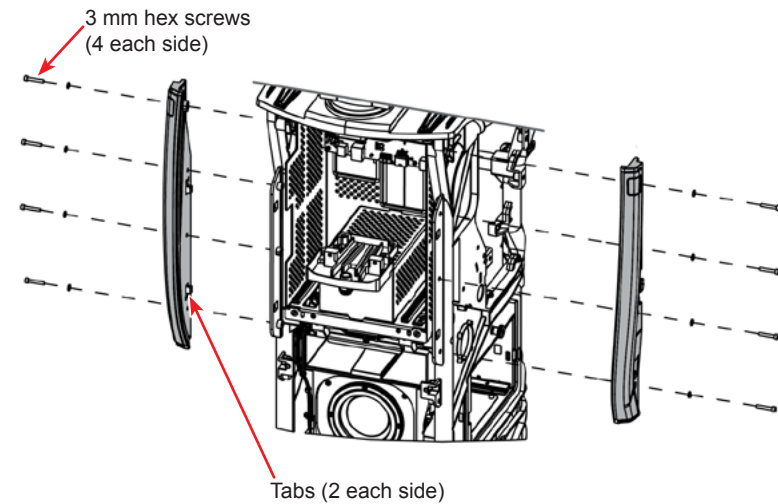
- 43.1 Remove front and upper side panels (left or right as necessary for PEL Assembly to be replaced).
- 43.2 Disconnect cable from PEL PCB.
- 43.3 Remove four 3 mm hex screws and washers securing PEL Assembly to chassis (see [Figure 3-52](#)).

Figure 3-52 PEL Assembly Removal

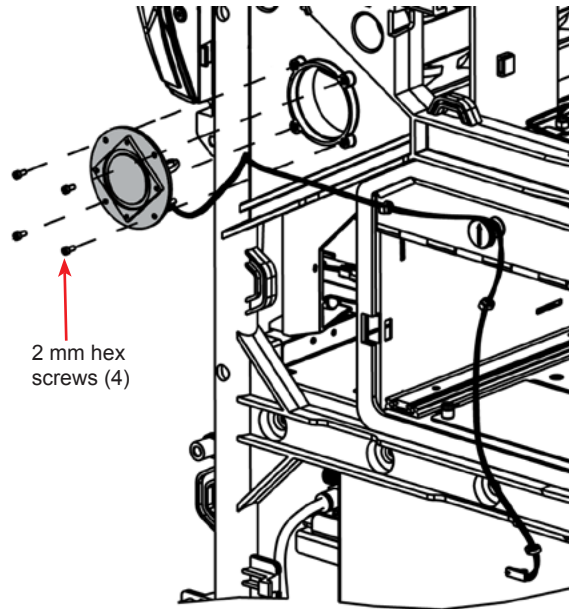
- 44.1 Remove upper and lower rear panels, and upper and lower side panels (left or right as appropriate for speaker to be removed).
- 44.2 Remove four 2 mm hex screws securing speaker/cable assembly to chassis (see [Figure 3-53](#)).

Figure 3-53 Side Speaker Removal

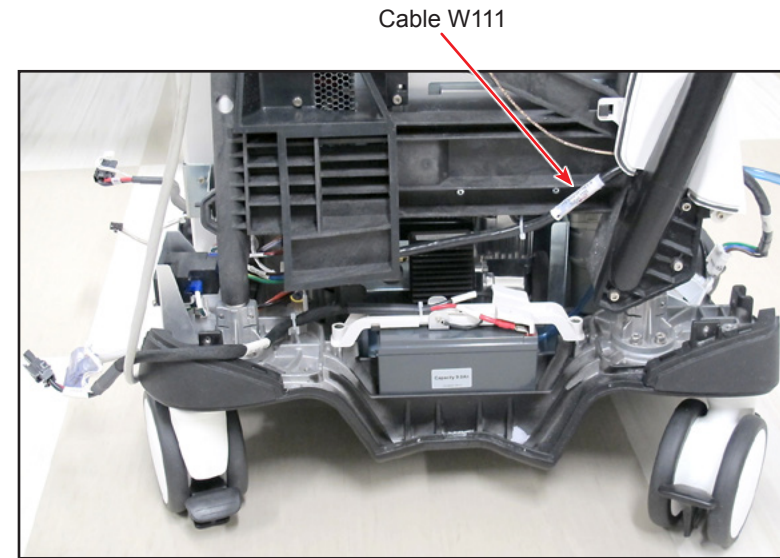
- 45.8 Disconnect W111 P1 from Power Supply and cut two tie wraps securing cable to frame. Move the cable away from frame. See [Figure 3-54](#) for routing of cable during replacement.

Figure 3-54 Cable W111 Routing Reference

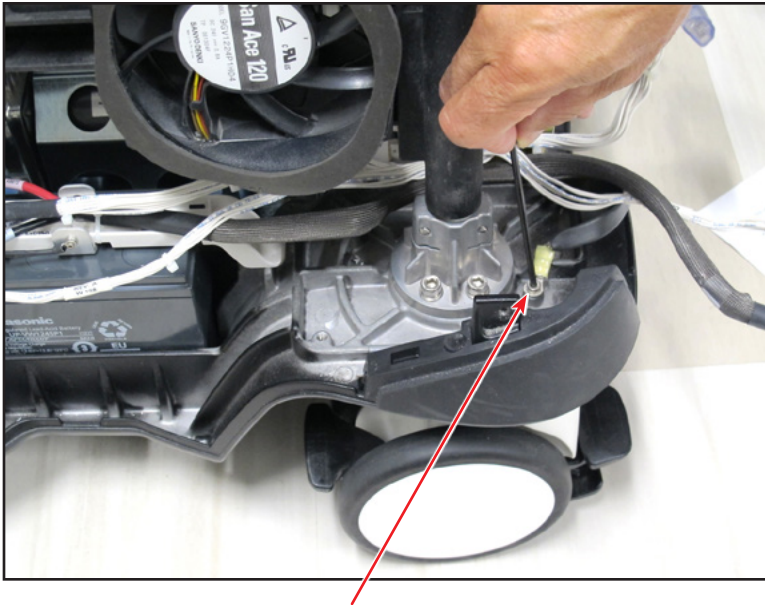
- 45.9 Loosen three 2.5 mm captive screws securing Power Entry Switch assembly to base. Separate assembly from base.
- 45.10 Remove the 40A fuse (F6) on the MFIO PCB.
- 45.11 Disconnect console batteries connectors J15, J27, J24, and J26 on the MFIO PCB.
- 45.12 Disconnect W107 J11 and J21, W108 J20 from MFIO PCB (these cables are from the footswitch connector bracket).
- 45.13 Disconnect W127 J4 from MFIO PCB (this cable is from the Pneumatic Pump).
- 45.14 Remove one 3 mm hex screw securing W181 IV Pole ground cable to base. See [Figure 3-55](#) for screw location.

Figure 3-55 IV Pole Ground Screw Location

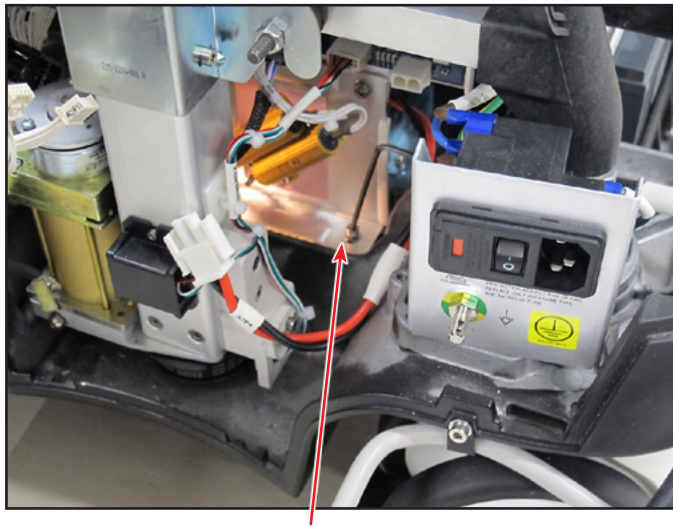
- 45.15 Remove two 3 mm hex screws securing Cable Load bracket to chassis. See [Figure 3-56](#) for screw location.

Figure 3-56 Cable Load Bracket Screw Location

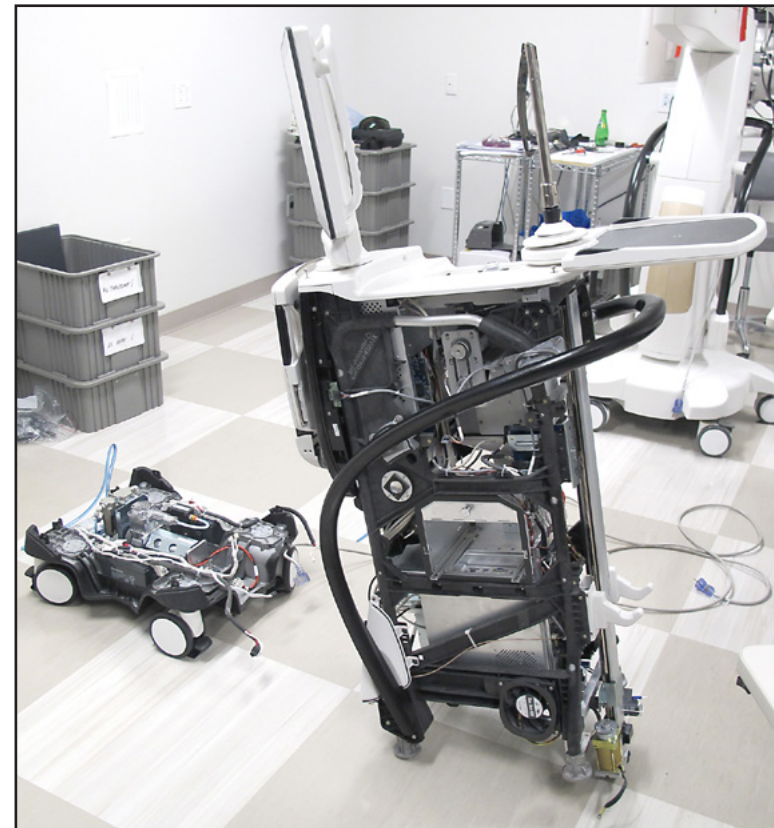
- 45.16 Remove sixteen 5 mm hex screws (four screws and washers for each frame foot/stand) securing system frame feet/stands to the Base.
- 45.17 Lock all four casters
- 45.18 With two people, evenly lift the entire system away from the Base and carefully place it on the floor in the upright position as shown in [Figure 3-57](#).

The system will partially rest on the IV pole assembly and has a higher probability of tipping in this position.

Figure 3-57 System removed from base.

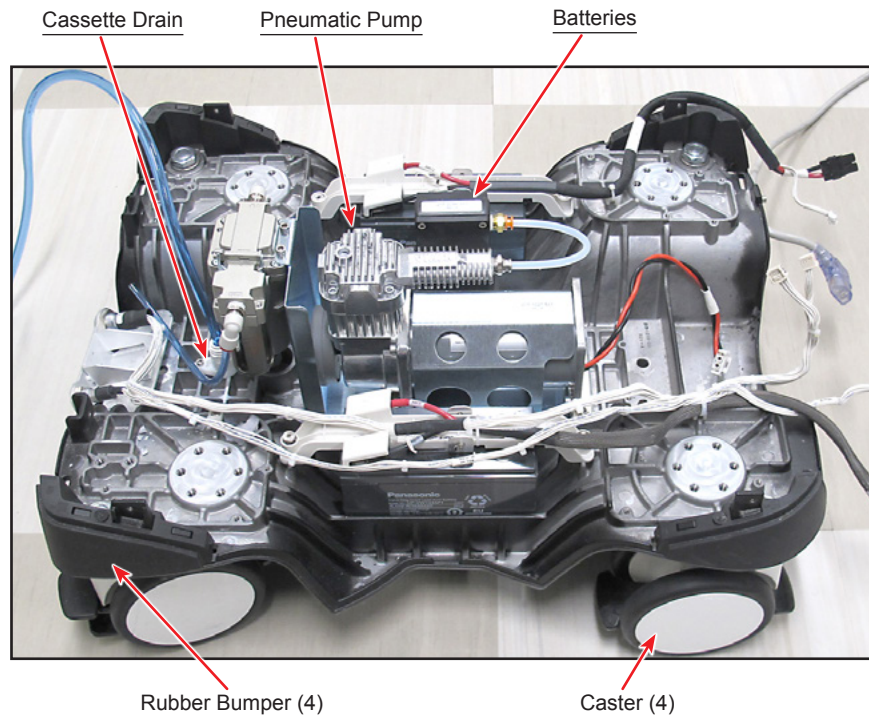
45.19 Remove the following items from the old base and install them to the new base (refer Table 3-1). [Figure 3-58](#) is provided as reference.

- Two console batteries and their brackets
- Pneumatic Pump
- Four rubber bumpers
- Four casters
- Cassette Drain secured by one 2.5 mm hex screw.
- Cut tie wraps as necessary and transfer cables to new base.

Figure 3-58 Reference Photo of Base

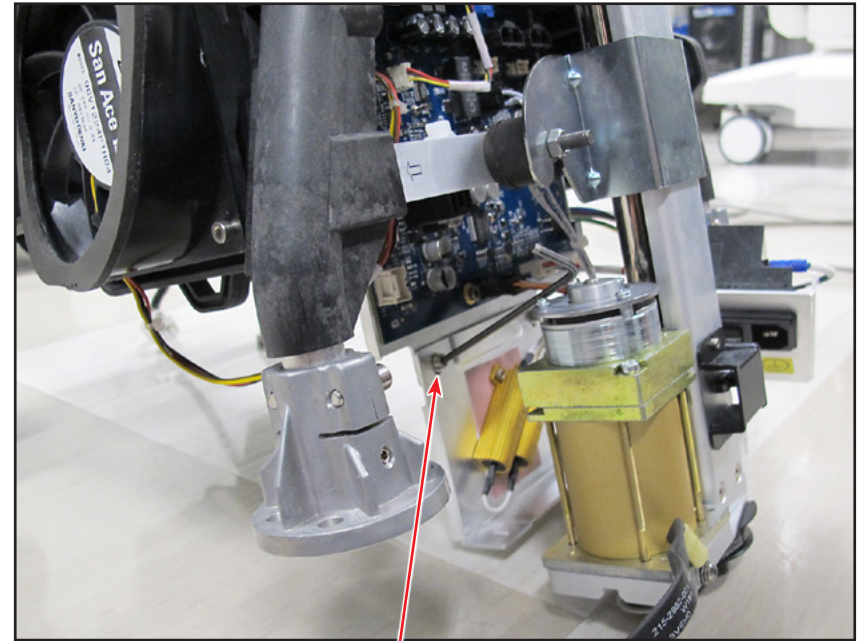
45.20 On the console, loosen two 3mm screws securing the cable load bracket to the bottom of the MFIO PCB assembly (see [Figure 3-59](#)). This will allow for fitting adjustments when attaching the new base. Be sure to adjust for proper fit and re-tighten when new base is attached.

Figure 3-59 Load Bracket Screws

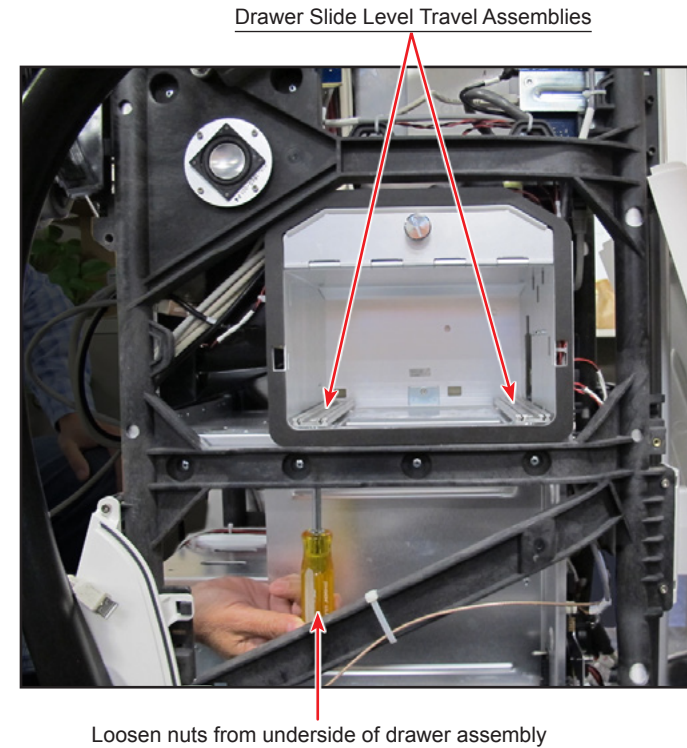
- 46.1 Remove the Drawer.
- 46.2 Remove the following items per Table 3-1:
 - Lower Front Panel
 - Lower Left Panel
 - Host Module
 - Pneumatic Main Manifold Assembly
- 46.3 Remove two 7 mm nuts securing each Drawer Slide Level Travel Assembly to chassis (see [Figure 3-60](#)). Nuts are accessed from underside the drawer assembly.
- 46.4 Remove each Drawer Slide Level Travel Assembly.

Figure 3-60 Location of Nuts Securing Drawer Slide Level Travel Assembly to Chassis

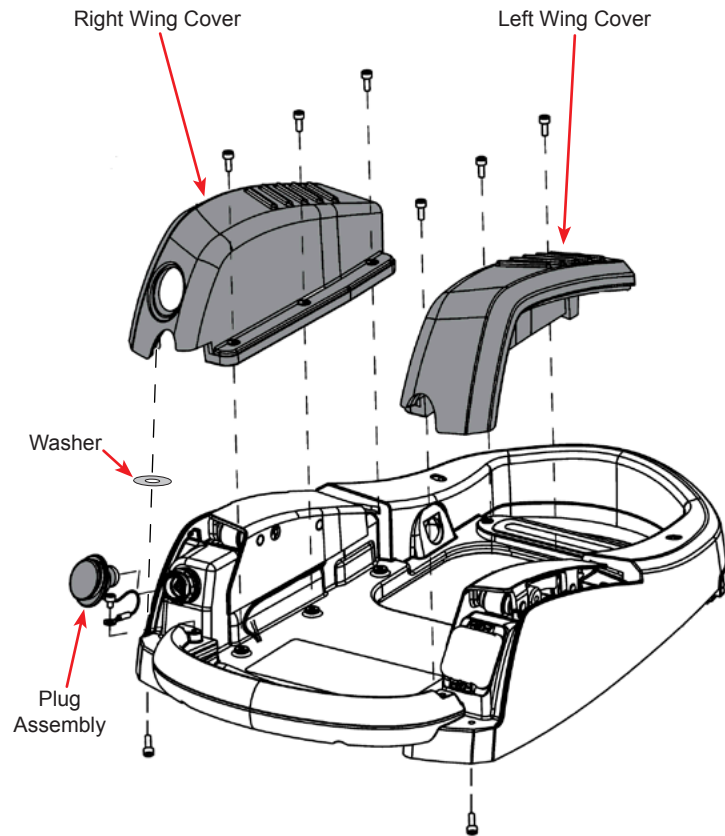
- 49.3 From underside of footswitch, remove one 2.5 mm hex screws securing each Cover to main housing (see [Figure 3-62](#)).

- 49.5 Remove Cover from footswitch, repositioning as necessary to slide it forward until it clears the footpedal. If removing the Right Cover, feed the connector plug assembly through the hole in the Cover prior to sliding it along the footpedal.

Figure 3-62 Footswitch Wing Covers and Connector Plug Assembly (shown without footpedal)

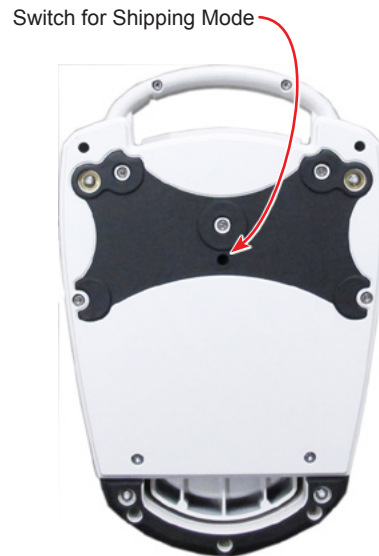
- 52.1 Set the footswitch to “shipping” mode by pressing and holding (for at least two seconds) the switch shown in [Figure 3-63](#) with a cotton swab or other instrument that can reach the recessed switch without damaging the rubber covering.

Figure 3-63 Location of Shipping Mode Switch

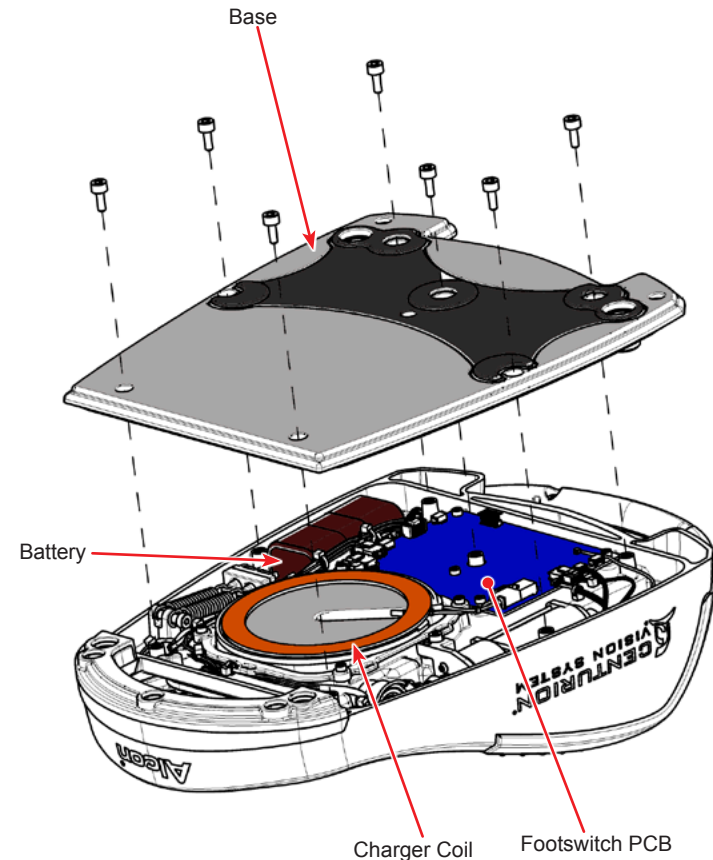
Figure 3-64 Footswitch Base Removal

- 52.2 Remove seven 4 mm hex screws securing Base to main housing (see [Figure 3-64](#)). Remove Base.
REPLACEMENT: Start all screws before tightening.

- 50.1 Remove seven 4 mm hex screws securing Base to main housing (see [Figure 3-61](#)). Remove Base.
REPLACEMENT: Start all screws before tightening.
- 50.2 Remove Battery and Charger Coil as directed in previous steps. These items are not secured to the footswitch (connected to PCB) and will fall out when footswitch is turned over.
- 50.3 Remove Right Wing Cover per step [49](#).
- 50.4 Note position of lanyard, then remove 2.5 mm hex screw securing Plug Assembly to chassis. Remove Plug assembly.

- 51.1 Remove seven 4 mm hex screws securing Base to main housing (see [Figure 3-61](#)). Remove Base.
REPLACEMENT: Start all screws before tightening.
- 51.2 Disconnect connectors from PCB at:
 - J2 -> W264 to Battery
 - J5 -> W260_1 & _2 to Left Switch
 - J6 -> W260_3 & _4 to Right Switch
 - J11 -> W266 to UP SWITCH PCB, LED PCB's
 - J12 -> W265 to Encoder
 - J13 -> W203 to Motor
 - J14 & J20 -> W267 to Console Connector
 - J18 -> W233 to Charger Coil
 - J21 -> W268 to Antenna
- 51.3 Remove five 2.5 mm hex screws securing Footswitch PCB to housing.
REPLACEMENT: Start all screws before tightening.
- 51.4 Remove Footswitch PCB from housing.

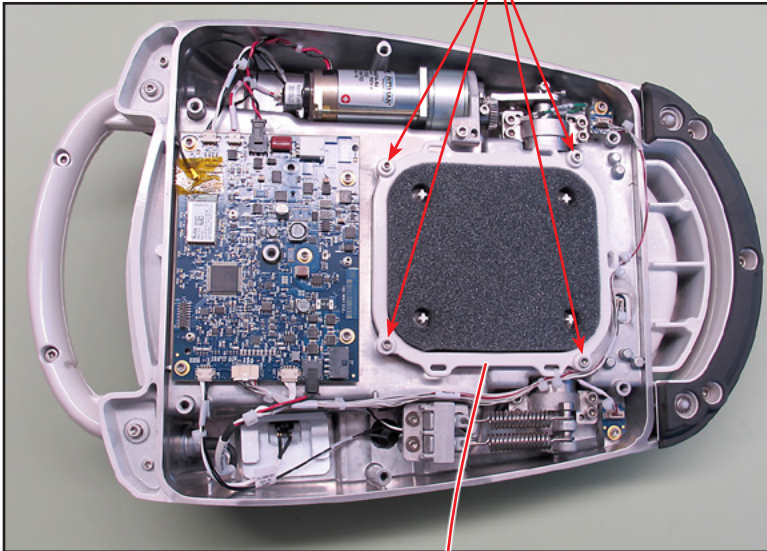
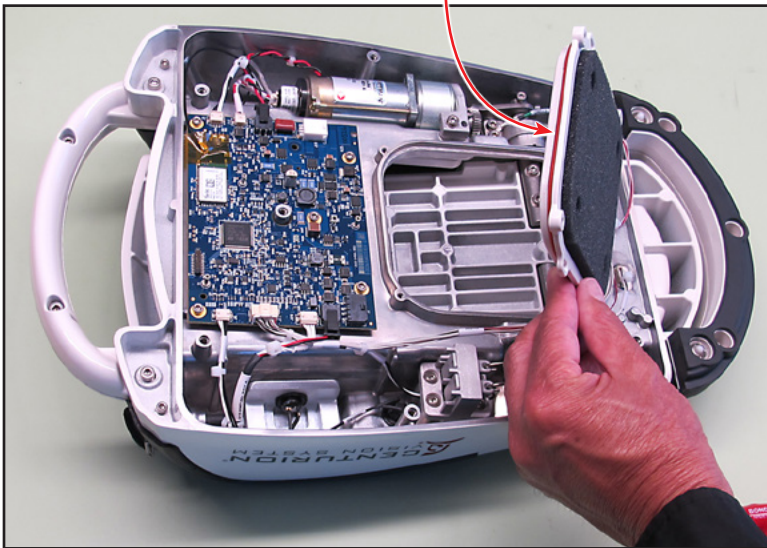
Figure 3-65 Removal of Footswitch Inner Cover

- 52.3 Remove Battery and Charger Coil as detailed in the steps below. These items are not secured to the footswitch (connected to PCB) and will fall out when footswitch is turned over.
- 52.3.1 Disconnect Battery from J2 on Footswitch PCB. Remove Battery.
- 52.3.2 Disconnect Charger Coil from J18 on Footswitch PCB. Remove Charger Coil.
- 52.4 Remove four 2.5 mm securing the Inner Cover (see [Figure 3-65](#)). Remove Inner Cover with O-Ring attached to it and Pressure Pad.

2.5 mm hex screws securing Inner Cover

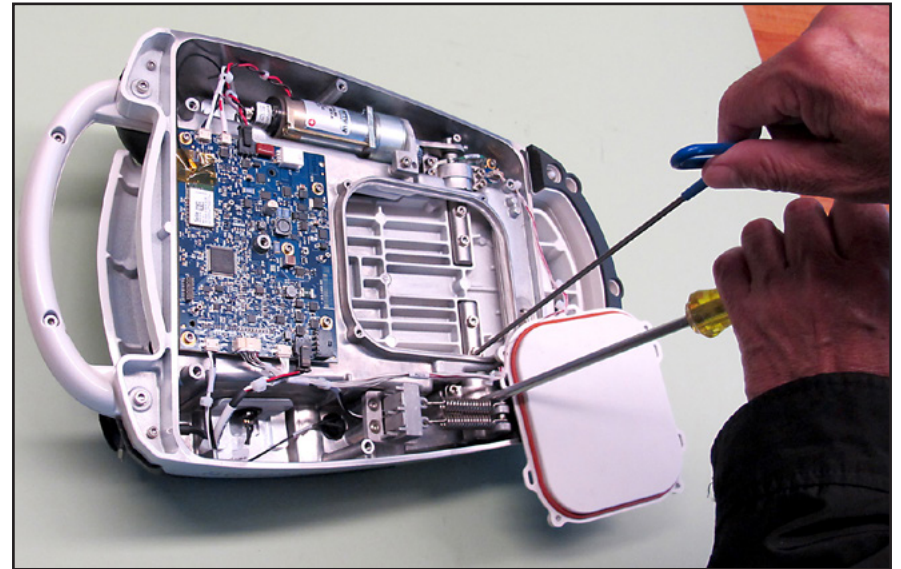
Figure 3-66 Removing the Treadle from the Spring-Loaded Shaft

52.5 While using a screwdriver to hold the spring-loaded shaft in place as shown in [Figure 3-66](#), remove the two 3 mm screws (closest to the spring) securing the treadle to the spring-loaded shaft.

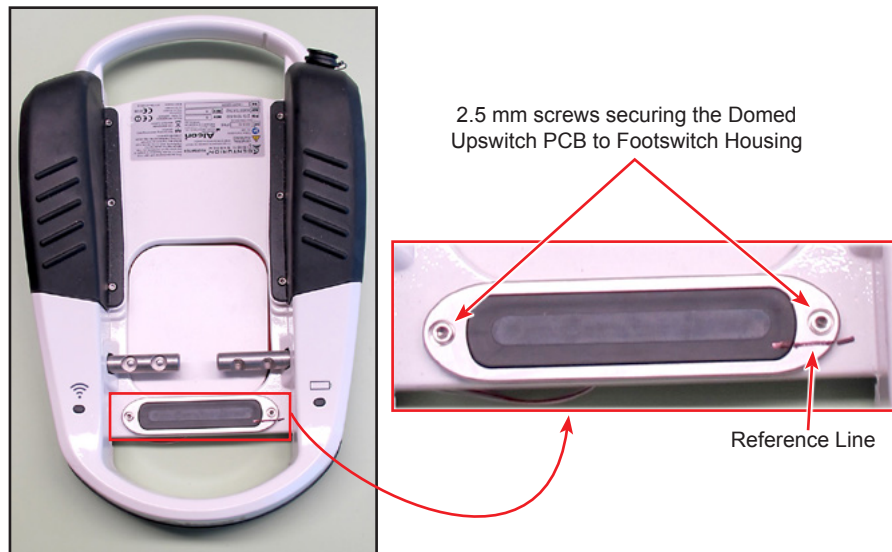
Figure 3-67 The Domed Upswitch PCB Assembly Secured to the Main Housing

- 52.8 Use a marker to make a reference line marking the position of the Domed Upswitch PCB Assembly to the main housing (see [Figure 3-67](#)).

- 52.11 Replace the Domed Upswitch PCB and install the assembly to the main footswitch housing in the same position as indicated by the reference line.
- 52.12 Install the remaining items in reverse order.

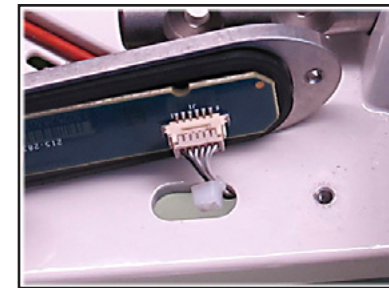
Figure 3-68 Domed Upswitch PCB Connector

- 52.9 Remove two 2.5 mm screws securing the Domed Upswitch PCB assembly to the Footswitch Housing.
- 52.10 Lift assembly from footswitch housing and disconnect connector shown in [Figure 3-68](#). The assembly includes the Topout Frame, Topout Diaphragm, and Domed Upswitch PCB (see [Figure 3-69](#)).

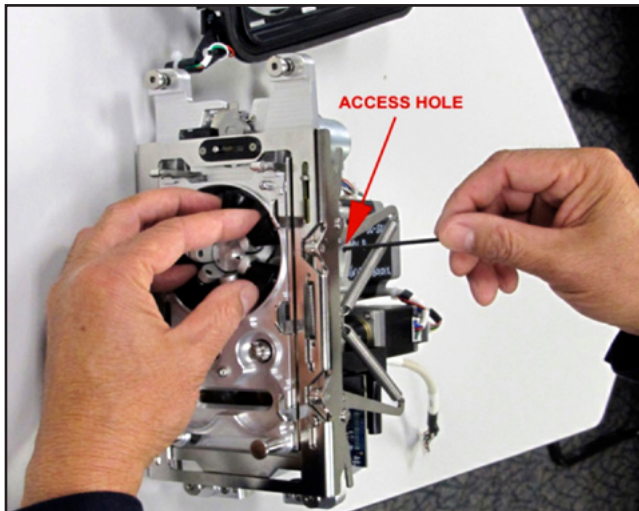
Figure 3-70 Loosening the Hub Roller Locking Screw

- 53.1 Remove Fluidics Module per step [18](#).
- 53.2 Place Fluidics Module on a secure location as shown in [Figure 3-70](#).
- 53.3 Insert a 2 mm Allen wrench to the access hole and manually rotate Hub Roller until the tip of the 2 mm Allen wrench is lined up with Hub Roller locking screw (see [Figure 3-71](#)).
Note: You cannot see the Hub Roller locking screw but rotating the Hub Roller will eventually allow the tip of Allen wrench to drop into the Hub Roller locking screw.
- 53.4 Loosen Hub Roller locking screw approximately two full turns then remove the Allen wrench.
- 53.5 Remove Hub Roller by pulling it straight out from the Fluidics Module (see [Figure 3-72](#) where two needle-nosed pliers are used to pull hub rollers).
- 53.6 Install the replacement Hub Roller in reverse order.

- 54.1 Remove Fluidics Module per step [18](#).
- 54.2 Place Fluidics Module on a secured location as shown in [Figure 3-70](#).
- 54.3 Using a permanent felt marker, draw a line on all four fluidics latch springs as shown in [Figure 3-74](#). This will prevent mixing up the old springs with the replacement springs.

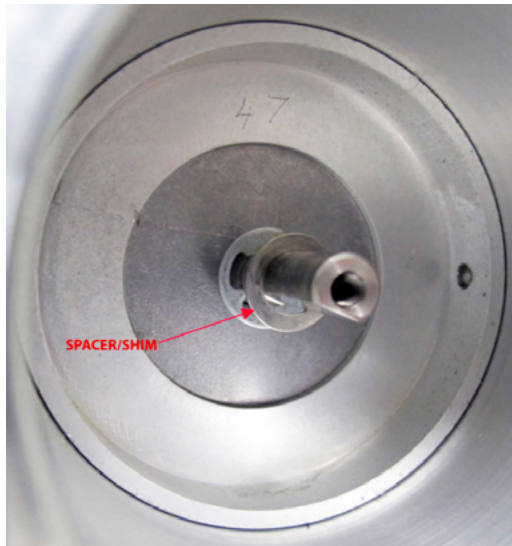
Figure 3-73 Removal of Spacer/Shim from Hub Rollers Assembly

NOTE: Hub Rollers assembly P/N 215-3254-502 was released in January 2015 with a cut in system serial number of 150102601X. This new Hub Rollers assembly was released to eliminate the need for adding a spacer/shim to the Hub Rollers assembly shaft. Therefore, installing the new Hub Rollers assembly on systems below serial number 150102601X, requires removal of the spacer/shim prior installing Hub Rollers assembly (see [Figure 3-73](#)). Conversely, installing the old Hub roller assembly on systems with serial number 150102601X and above requires the installation of the spacer/shim (PN 215-3127-003).

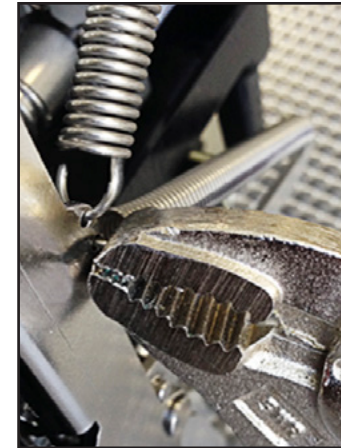
Figure 3-75 Latch Spring Removal

- 54.4 Remove all four latch springs and place them outside the work area to prevent mixing with replacement springs. It is recommended to remove the springs from the latching mechanism using small locking pliers as shown in [Figure 3-75](#).

- **Do not over-extend the springs during removal and installation.**
 - **Also, take care to not bend the spring latch arms.**
- 54.5 Install replacement latch springs with the open end of the hook towards the module as shown in [Figure 3-75](#).
NOTE: It is recommended to use locking pliers and pull the spring towards the main part of the latching mechanism as shown in [Figure 3-75](#).
 - 54.6 Install the Fluidics Module and Fluidics PCB assembly back into the console. Reassemble the console.

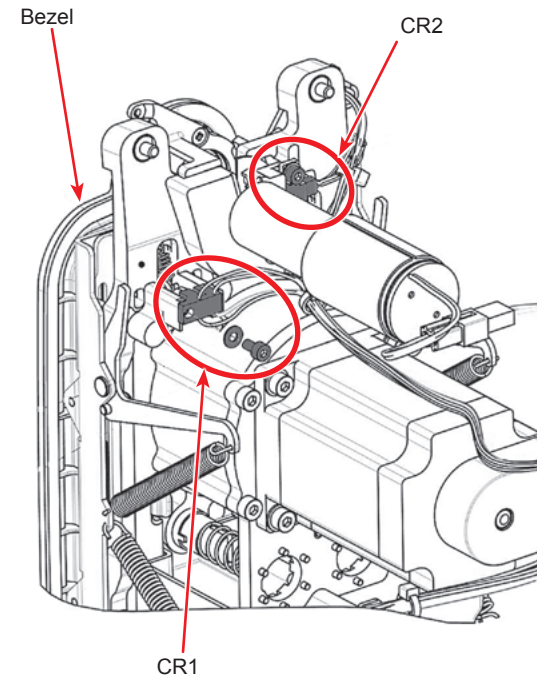
Figure 3-76 CR3 Sensor Cable Removal

- 55.1 Remove Fluidics Module per step [18](#).
- 55.2 Separate Fluidics Bezel from module by pulling it straight out from Fluidics Module. The Bezel is still attached to the module by cable W115.
- 55.3 Remove two 2.5 mm hex screws securing sensor CR2 to Fluidics chassis ([Figure 3-76](#)).
- 55.4 Remove 2.5 mm hex screw securing CR1 sensor to Fluidics Module chassis. Pull sensor away from module.
- 55.5 Disconnect cable W115 from Fluidics PCB at connector J9.
- 55.6 Cut tie wrap securing cable W115 to Fluidics Module.
- 55.7 Remove Bezel from Fluidics Module

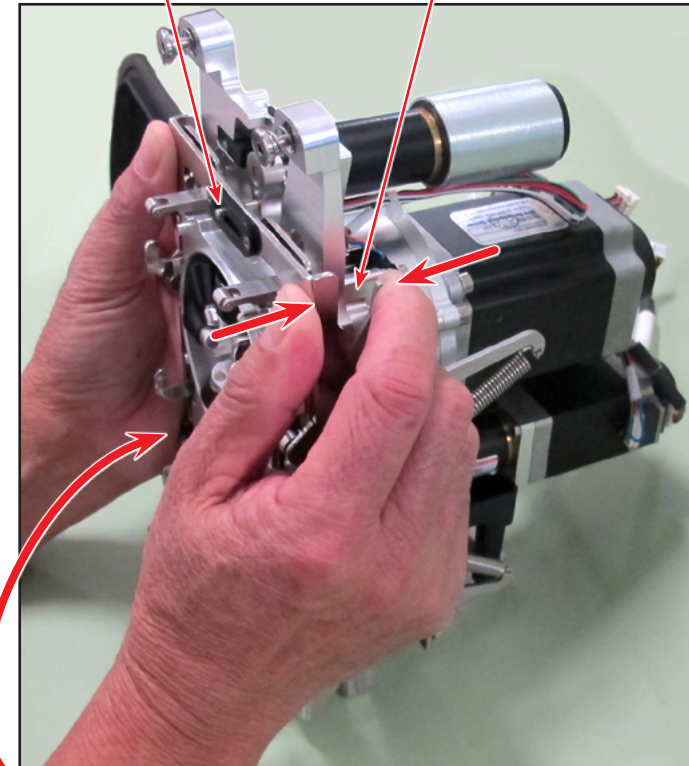
Figure 3-77 Clamp Bracket Removal

- 56.1 Remove Fluidics Module per step [18](#).
- 56.2 Place Fluidics Module on a secure location.
- 56.3 Place hands on both sides of Clamp Bracket as shown in [Figure 3-77](#). Place right thumb on upper right corner and left thumb on upper left corner. Place index fingers on the upper right/left Top Clamp Roller Hinges and squeeze. While squeezing, slightly use your palms to push in the lower part of the Clamp Bracket, and pull the Top Clamp Bracket outward (toward yourself) until the Latch Motor drive wheel pin is clear from the slot and the Clamp Bracket can be lowered and removed from the module.

Latch motor drive pin must clear slot in order for clamp to release from module.

Squeeze Clamp and Clamp roller hinges.

With both palms, push lower part of clamp bracket inward.

- 56.4 REPLACEMENT:
 - 56.4.1 When installing Clamp Bracket, ensure the Latch Motor drive wheel pin touches the top Clamp Bracket (close to the slot that the wheel pin will come in).
 - 56.4.2 Using the same technique mentioned in step [56.3](#) to install the Clamp Bracket so the wheel pin will be inserted to the slot.

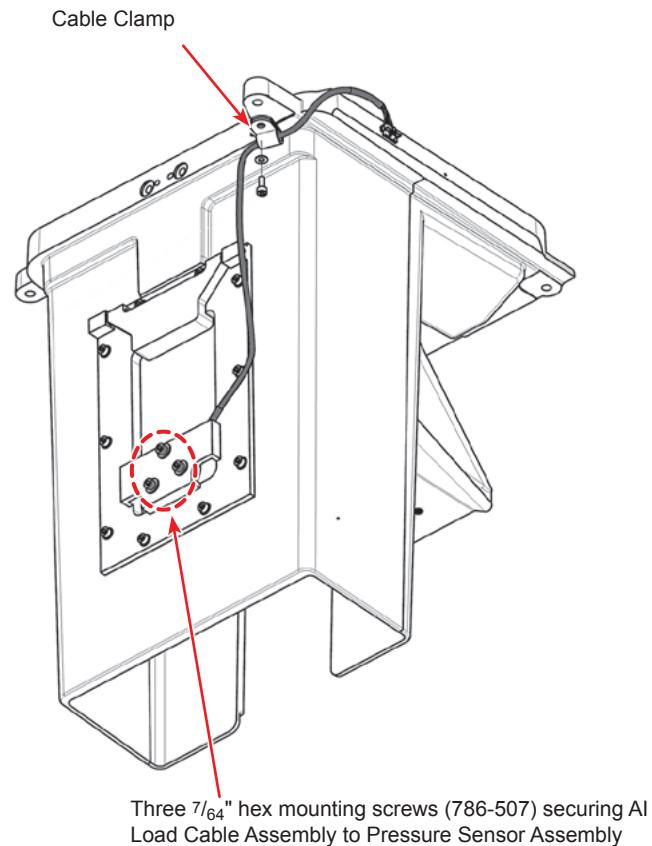
Figure 3-78 Active Irrigation Load Cable Assembly Removal from AI Module

- 57.1 Remove AI Module per step [21](#).
- 57.2 Remove three $\frac{7}{64}$ " hex mounting screws securing AI Load Cable Assembly to Pressure Sensor Assembly (see [Figure 3-78](#)). **REPLACEMENT:** Tighten mounting screws evenly but do not over-tighten..
- 57.3 Remove 2.5 mm hex screw and washer securing cable clamp to AI module.
- 57.4 Remove AI Load Cable Assembly from AI Module.

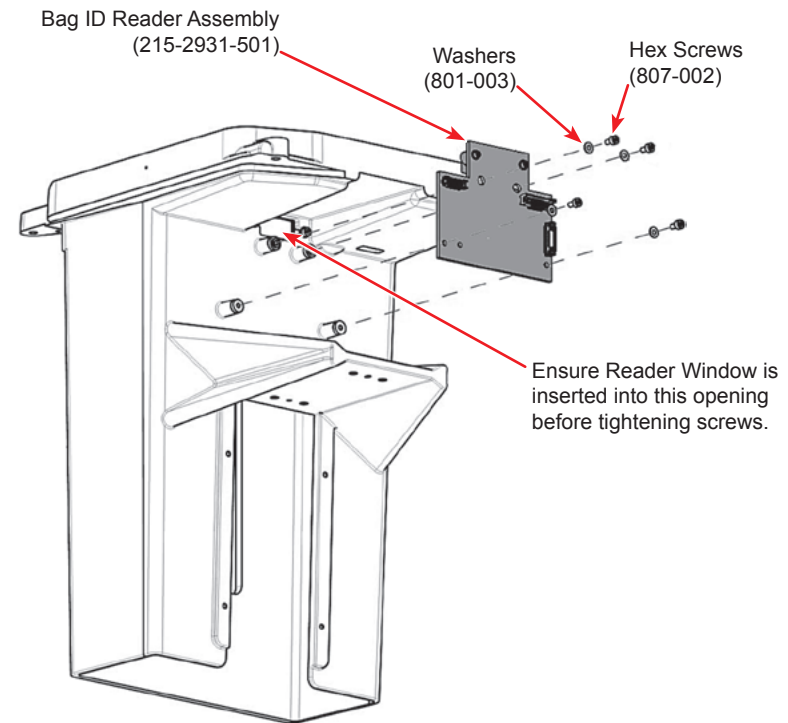
Figure 3-79 Active Irrigation Bag ID Reader PCB Removal

- 58.1 Remove Active Irrigation Module per step [21](#).
- 58.2 Remove four 2.5 hex screws and washers securing Bag ID Reader PCB to AI Module (see [Figure 3-79](#)).

- 58.3 Remove Bag ID Reader PCB Assembly by pulling it straight out and away from AI Module.
- REPLACEMENT:** Ensure the Reader Window is inserted into the opening slot before tighten mounting screws.

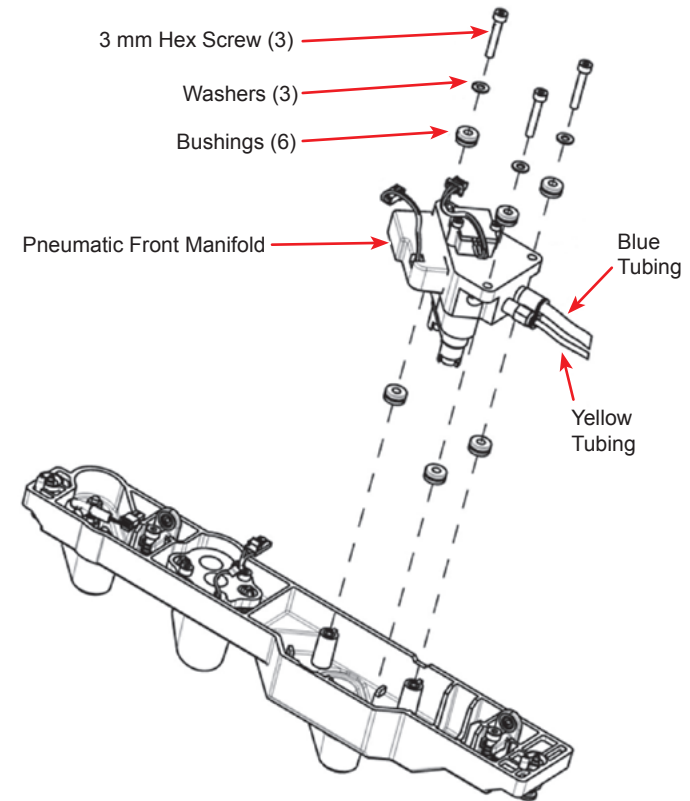
Figure 3-80 Pneumatic Front Manifold Removal

- 59.1 Remove Fluidics Controller Assembly (215-1007-50X) per step [18](#).
- 59.2 Disconnect four connectors from the Fluidics Controller PCB: J10, J11, J14, and J15.
- 59.3 Remove two 2 mm hex screws and two washers securing Fluidics Controller PCB to the Connector Panel.
- 59.4 Remove two Pneumatic tubings (blue and yellow) from the Pneumatic Front Manifold.
- 59.5 From the Connector Panel, remove three 3 mm hex screws, three washers, six bushings, securing Pneumatic Front Manifold (see [Figure 3-80](#)).
- 59.6 Remove Pneumatic Front Manifold.

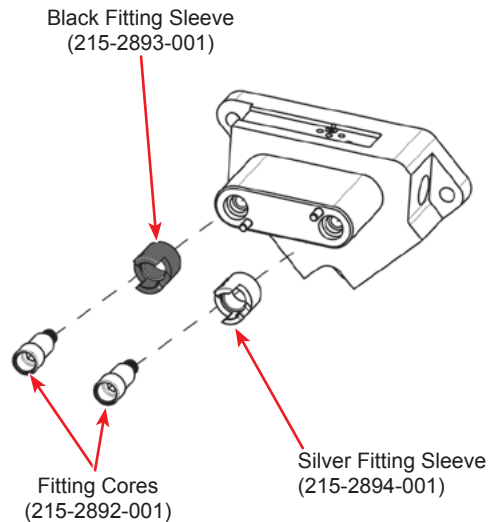
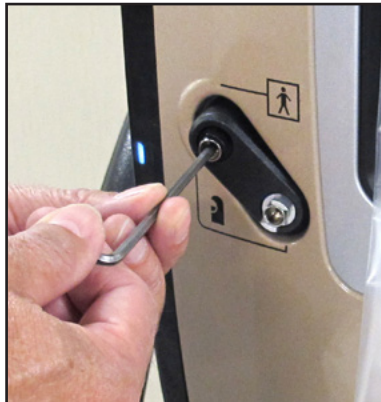
Figure 3-81 Pneumatic Fittings Removal

- 60.1 Using a 1/8 inch hex wrench, loosen the Pneumatic Fitting and remove from connector panel (see [Figure 3-81](#)). Both the Fitting Core and Fitting Sleeve should come out.

REPLACEMENT: Ensure that Fitting Sleeve "cut-out" groove is properly fitted on the guide pin in the hole before tightening the Fitting in place.

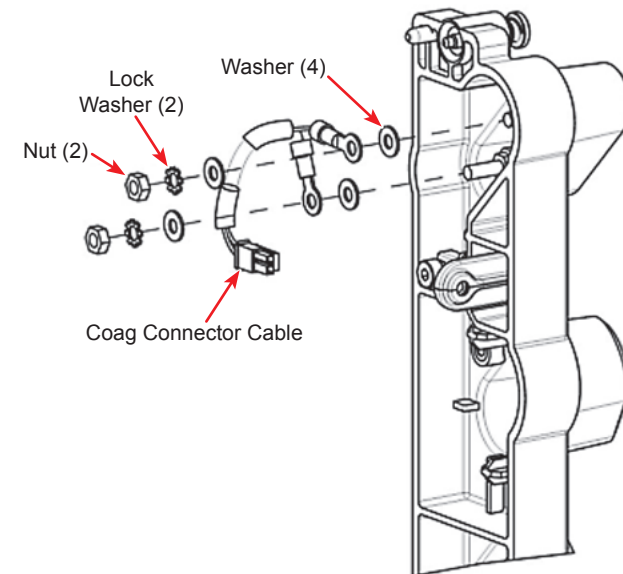
Figure 3-82 Removal of Coag Cable

- 61.1 Remove Fluidics Controller Assembly per step [18](#).
 61.2 Disconnect four connectors from the Fluidics Controller PCB: J10, J11, J14, and J15.
 61.3 Remove two 2 mm hex screws and two washers securing Fluidics Controller PCB to the connector panel.
 61.4 From the connector panel, remove nuts and washers securing Coag Connector Cable to two banana jacks (see [Figure 3-82](#)).

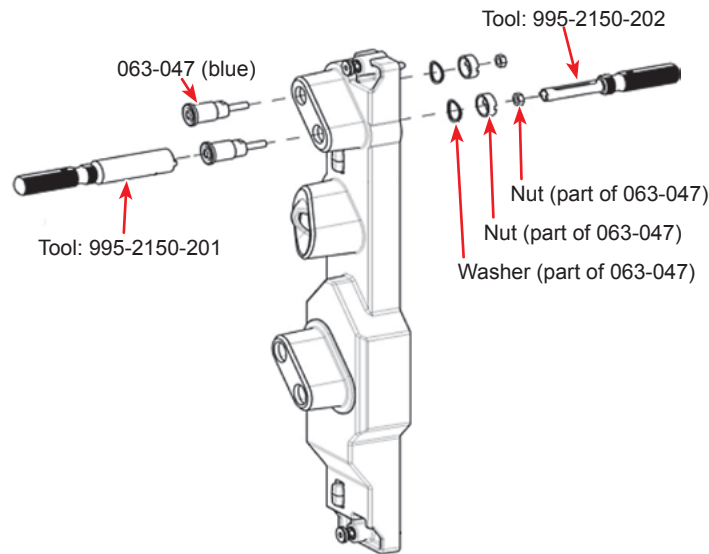
Figure 3-83 Coag Connectors Removal

- 61.5 Remove nuts and washers securing two banana jacks to panel housing using fixtures/tools 995-2150-201 and 995-2150-202 shown in [Figure 3-83](#).

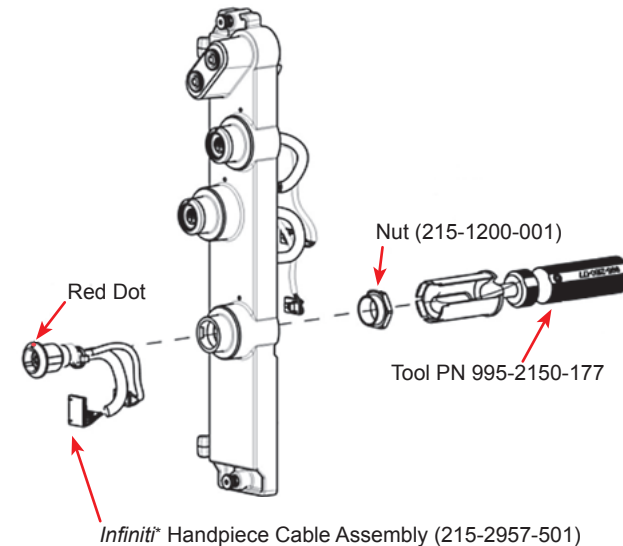
Figure 3-84 *Infiniti Handpiece Cable Assembly Removal**

- 62.1 Remove Ultrasonics (U/S) PCB Assembly per step [19](#).
- 62.2 Remove two 2 mm hex screws and washers securing Ultrasonics PCB to the assembly.
- 62.3 On the connector panel, remove nut securing *Infiniti* U/S Handpiece Cable Assembly (215-2957-001) using tool PN 995-2150-177 (see [Figure 3-84](#)). NOTE: Tool PN 995-2100-106 used on *Infiniti** systems also works for this connector.
- 62.4 Remove *Infiniti** U/S Handpiece Cable Assembly.

- 62.5 Remove and discard nut and washer from new *Infiniti** U/S Handpiece Cable Assembly.
- 62.6 Install the new *Infiniti** U/S Handpiece Cable Assembly into the connector panel and ensure the red dot of the cable is facing up as shown in [Figure 3-84](#).

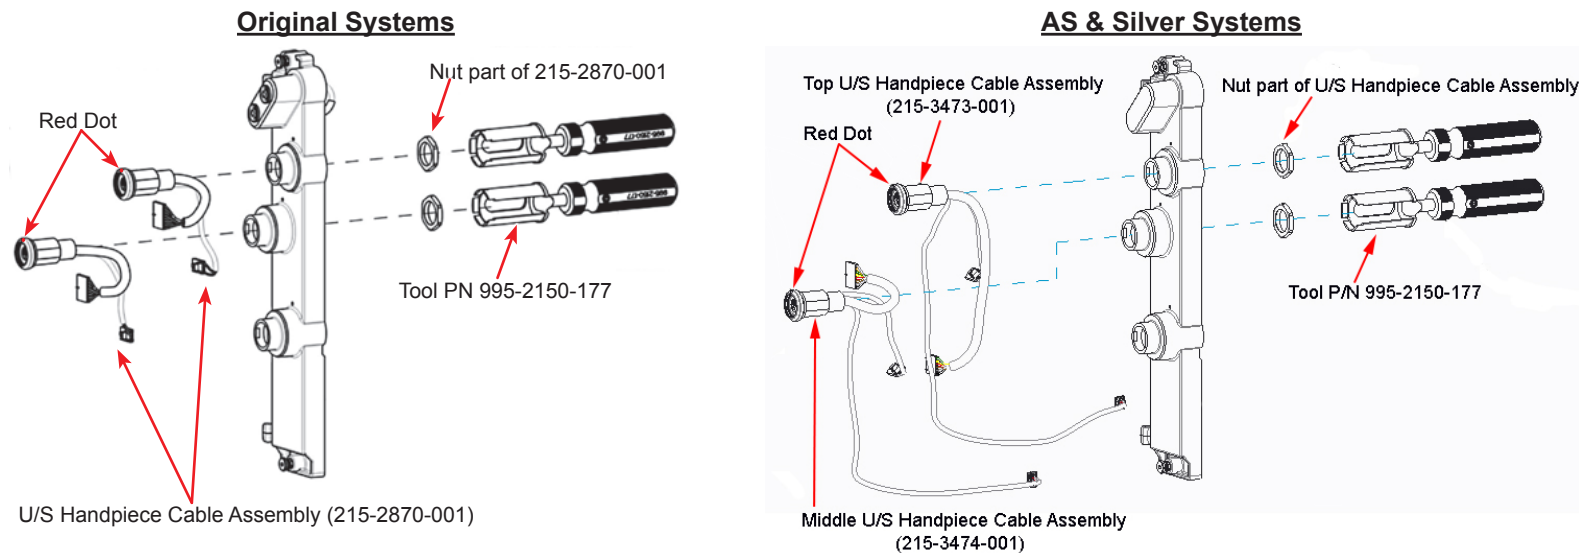
Figure 3-85 U/S Handpiece Cable Assembly Removal

- 63.1 Remove Ultrasonics (U/S) PCB Assembly per step [19](#).
 - 63.2 Remove two 2 mm hex screws and washers securing Ultrasonics PCB to the assembly.
 - 63.3 On the connector panel, remove nut securing U/S Handpiece Cable Assembly using tool PN 995-2150-177 as shown in [Figure 3-85](#). NOTE: Tool PN 995-2100-106 used on *Infiniti** systems also works for this connector.
 - 63.4 Remove U/S Handpiece Cable Assembly.
- REPLACEMENT:**
- 63.5 Remove nut from new U/S Handpiece Cable Assembly.
 - 63.6 Install the new U/S Handpiece Cable Assembly into the connector panel and ensure the red dot of the cable is facing up as shown.
 - 63.7 Secure cable assembly to connector panel with nut using tool PN 995-2150-177.

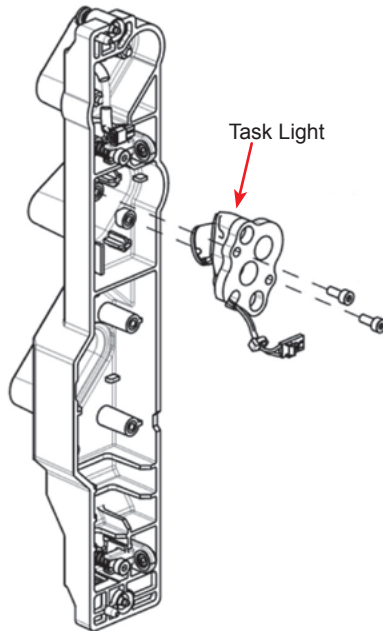
Figure 3-86 Task Light Removal

- 64.1 Remove Fluidics Controller Assembly per step [18](#).
- 64.2 Disconnect four connectors from the Fluidics Controller PCB: J10, J11, J14, and J15.
- 64.3 Remove two 2 mm hex screws and two washers securing Fluidics Controller PCB to the Connector Panel.
- 64.4 Remove two 3 mm hex screws securing Task Light Assembly to connector panel.
- 64.5 Remove Task Light Assembly.
